Manhole Inspection Summary

Manhole # S33K1_005MH

Insp Date: **3/24/08 10:01 AM**

Location Address: **2501 Seamon Ave.**

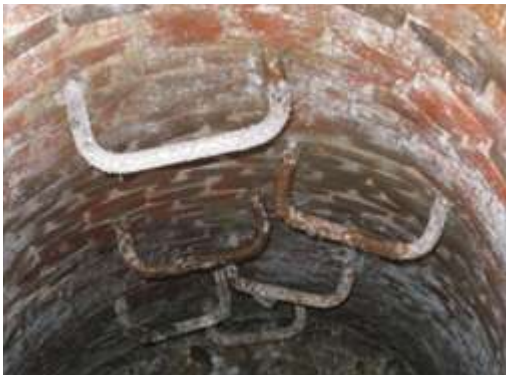
Steps Count: **6** Missing: **0** ☒ **Corroded**

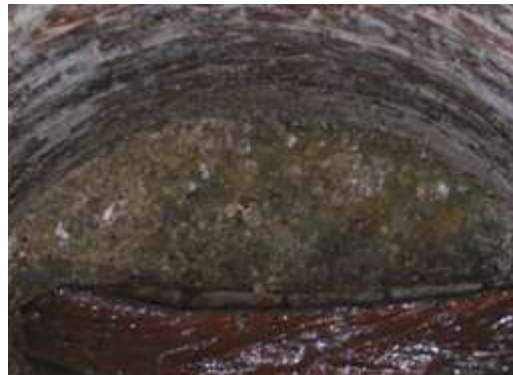
Defect 2

Bench

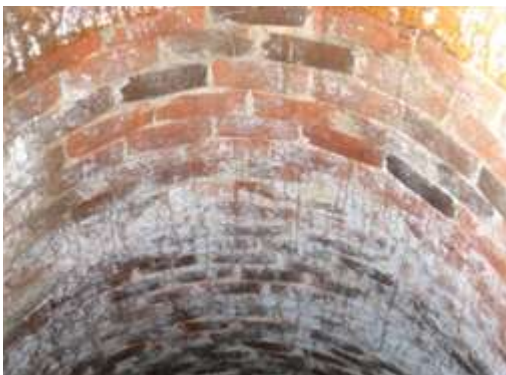
Defect 1

Infiltration: ☐ None ☐ Joint ☐ Cracks ☐ Mortar ☐ Roots ☒ **Wall**

Wall

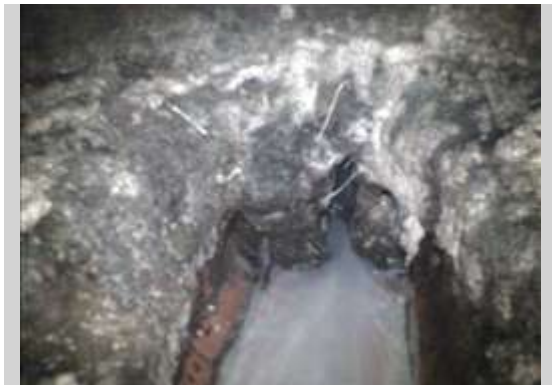
8 in. Circular Gravity Sewer
Pipe In @ 5 O'Clock

Pipe Height: **8.4** (in.) Rod and Bar (Angled)
Pipe Material: **Clay** ☐ Pipe Lined
Invert Depth: **11.13** (ft.) Flow Characteristics: **Fast**
Deposits: ☒ None ☐ Mud ☐ Sludge ☐ Debris ☐ Grease
Silt Depth: (in.) Deposits Extent:
Infiltration: **None** Pipe Seal Cond: **Sound**
